**SUMMARY OF FINDINGS
2020 Annual Outfall Underwater Survey
FINAL**

July 2020

Prepared for
Carmel Area Wastewater District
3945 Rio Road
PO Box 221428
Carmel, CA 93922
Attn: Patrick Treanor, P.E.

2020 Outfall Survey Summary Report

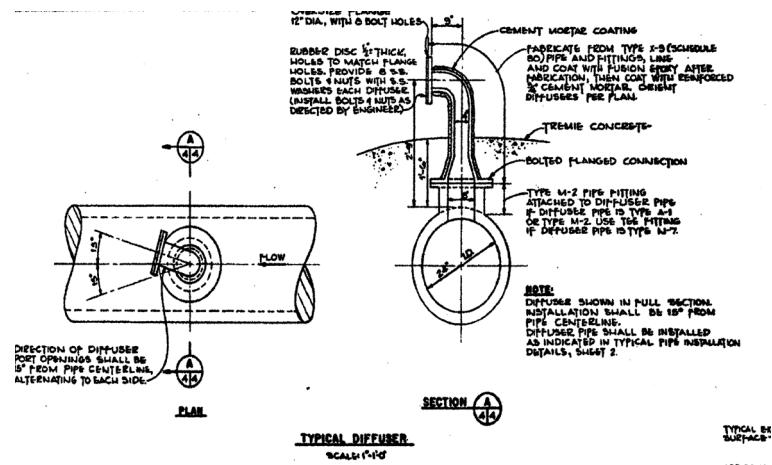
Figure 1 – Diffuser details in reference drawings

The reference drawings depict the diffusers as extending vertically out of the crown of the pipe and call out a horizontal offset of 15 degrees of the downstream flow direction for the duckbill valves. This 15-degree offset is shown as alternating with the odd duckbills at +15 and the even duckbills at -15 from the centerline of the pipe (Figure 1).

Rather than the alternating 15-degree offset from the downstream alignment of the pipeline axis, the actual alignment was observed to be (again) almost random with the alignment(s) being in multiple compass directions.

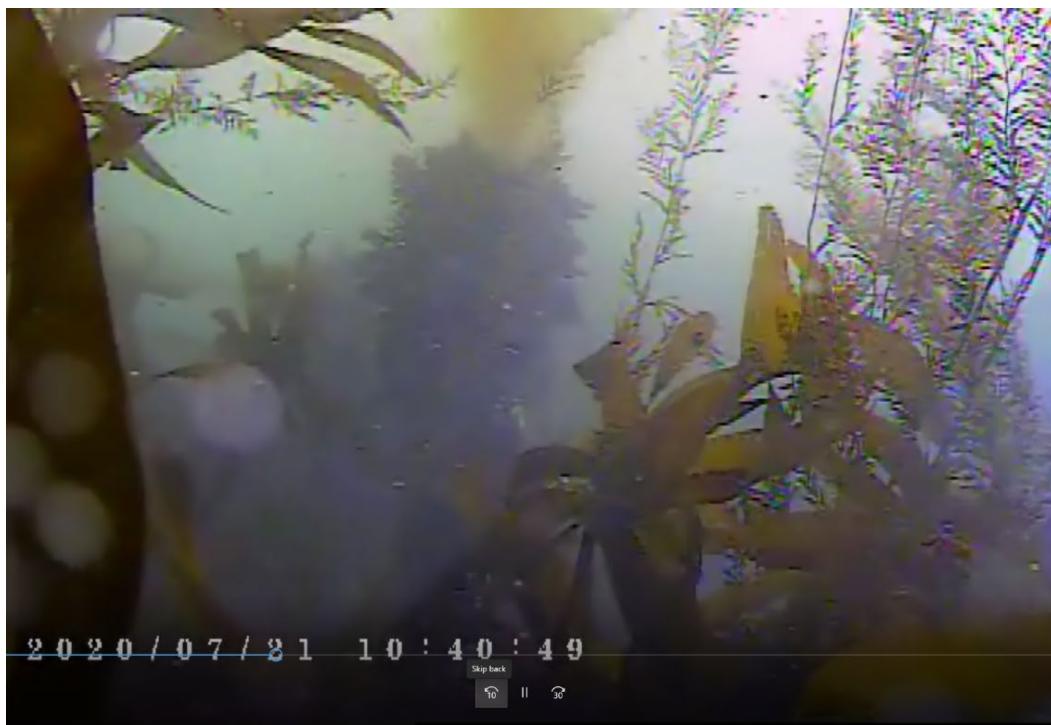
Image 3 – Discharge from Diffuser (typical)

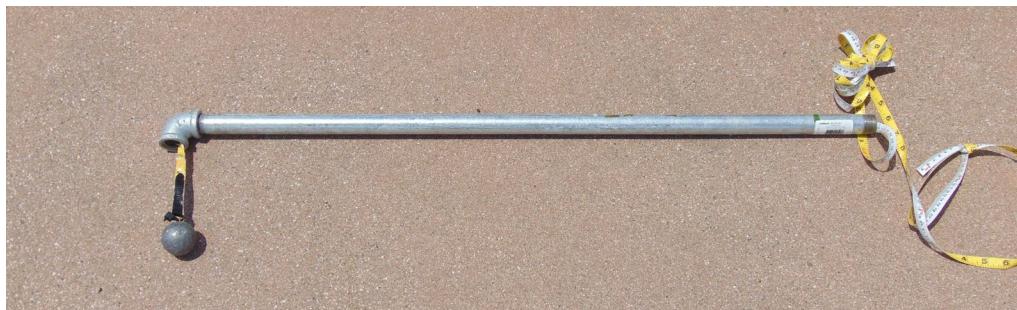
All ten of the diffuser ports were measured internally to detect sediment build-up. A 1-inch diameter galvanized steel pipe fitted with a 90-degree elbow at the insertion end was introduced through the duckbill valve to allow vertical sounding measurement using a flexible fiberglass tape measure weighted with a 16-ounce spherical lead weight.

Image 4 – Diffuser sounding device

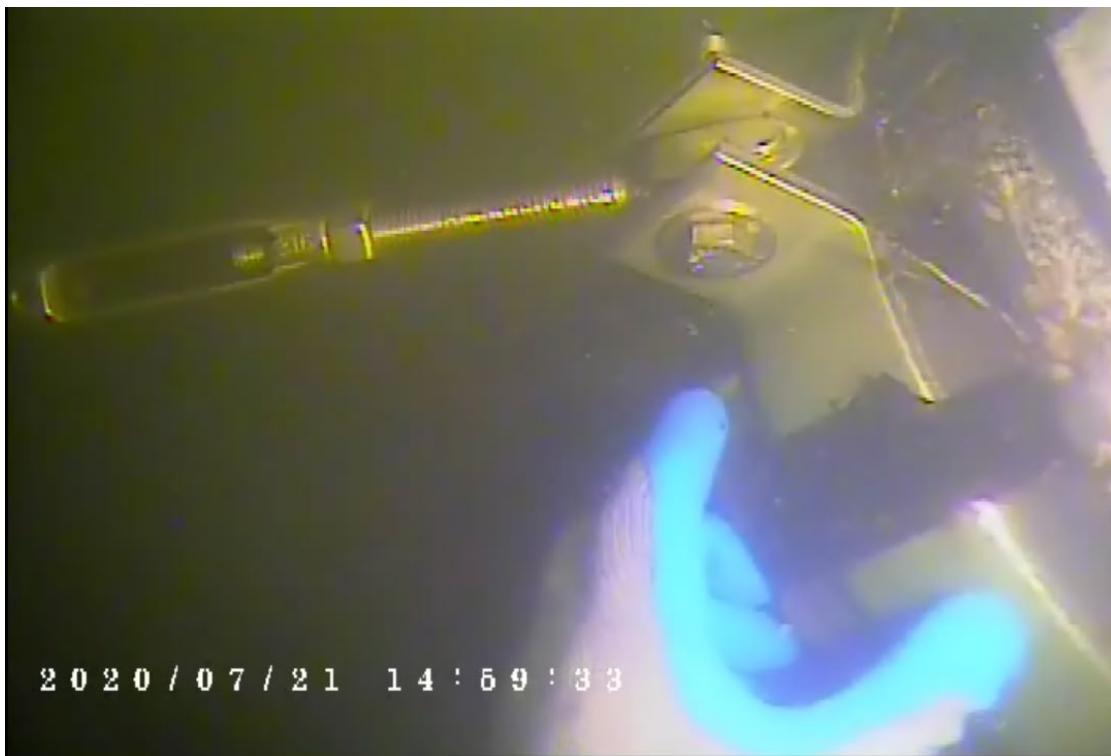
The soft reaction bracing is secure, without observable damage, and appears to be functioning as intended. The two-part clamps are all firmly in place, the cable clips are tight, and the turnbuckles remain snug in tension. The visible portions of the epoxy and woven fiber pile wrap appear to be in good condition and without observable damage, indicating that the upper portion(s) under the UV protective second sheathing wrap can be realistically assumed to be in good condition as well.

Image 5 – Upper clamp-to-turnbuckle connection of soft reaction bracing (typical)

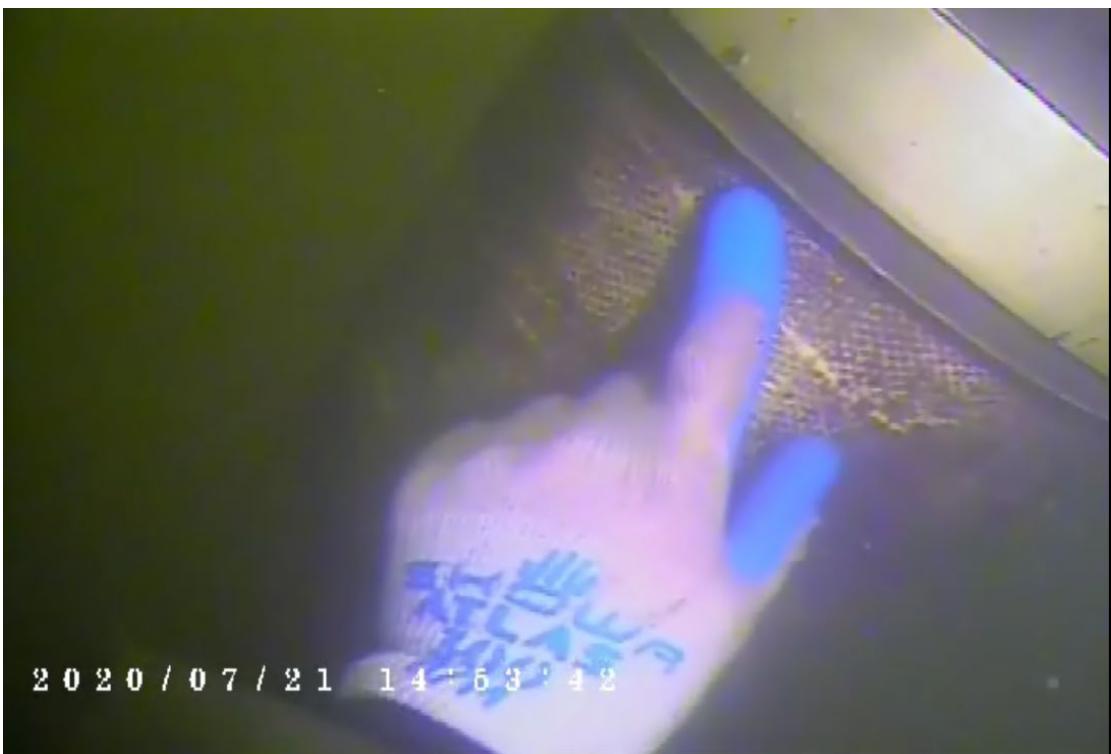
Image 6 – Lower epoxy and woven fiber wrap treatment with two-part clamp and rubber liner (typical)

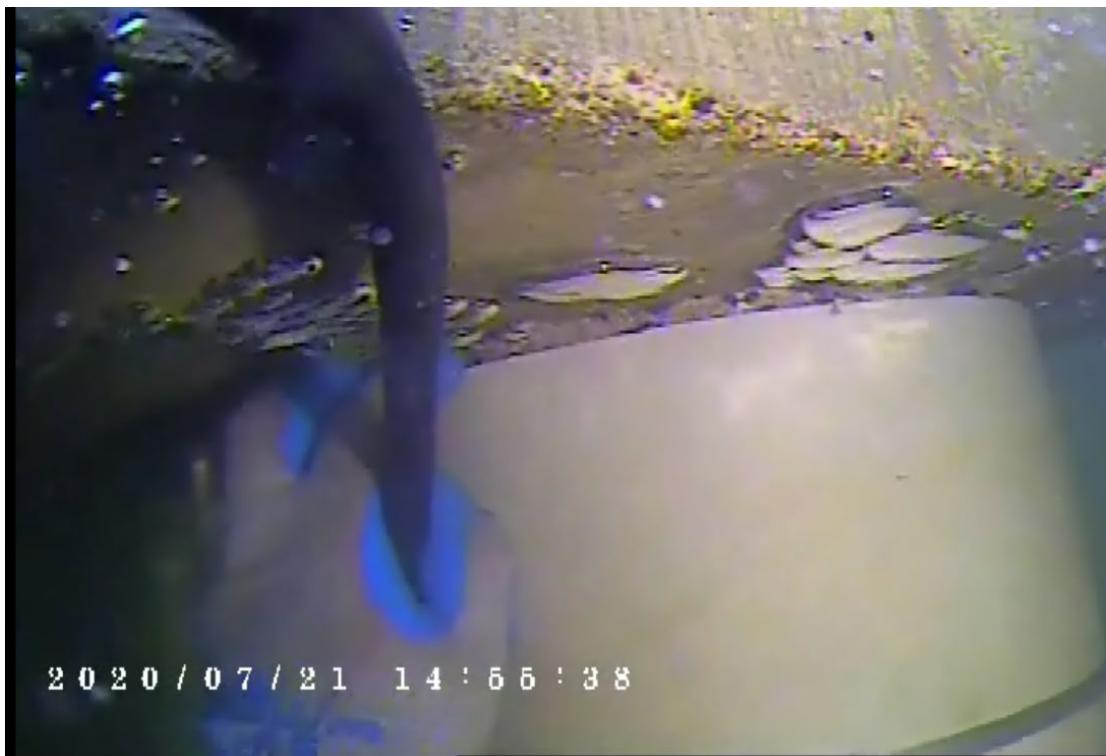
The diver reported the concrete repair encapsulations were in good condition at all three outfall support locations.

Image 7 – Interface of plastic UV protective wrap under concrete encapsulation (typical)
