SUMMARY OF FINDINGS
2023 Annual Outfall Underwater Survey
FINAL

October 2023

Prepared for
Carmel Area Wastewater District
3945 Rio Road
PO Box 221428
Carmel, CA 93922
Attn: Patrick Treanor, P.E.

2023 Outfall Survey Summary Report

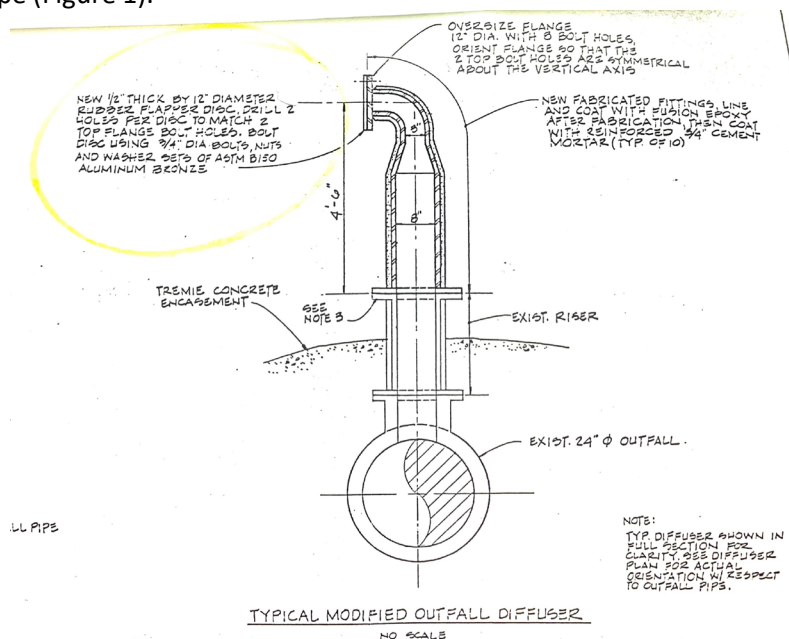
Figure 1 – Diffuser details in reference drawings

The reference drawings depict the diffusers as extending vertically out of the crown of the pipe and call out a horizontal offset of 15 degrees of the downstream flow direction for the duckbill valves. This 15-degree offset is shown as alternating with the odd duckbills at +15 and the even duckbills at -15 from the centerline of the pipe (Figure 1).

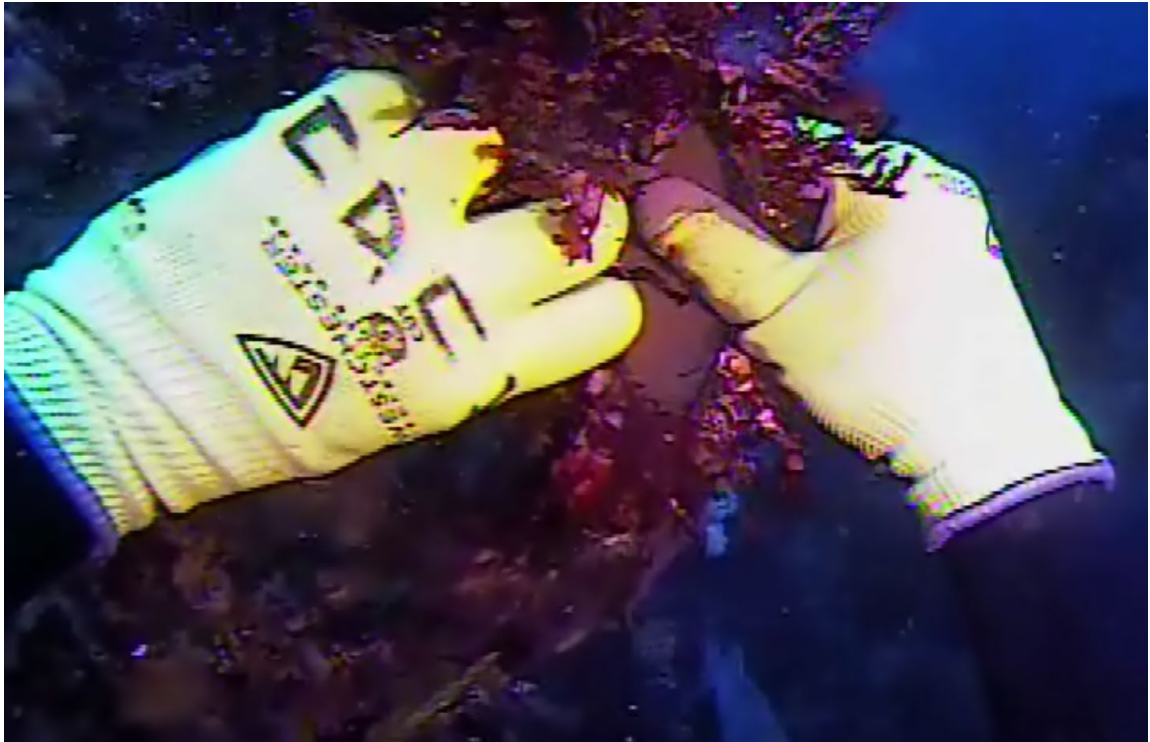
functioning as intended. The interior sealing surface of the rubber valves, or "lips" are clean and free from any marine fouling or observable deposits that would prevent full closure and full sealing contact when under a no-flow condition. With full closure contact, the migration of sediment from the ocean is prevented. Reference survey video file "2021_OutfallSurvey_DiffuserSection" from 10:07:40 to 10:07:50

Image 2 – Duckbill contact sealing surface during no-flow (2021 image)

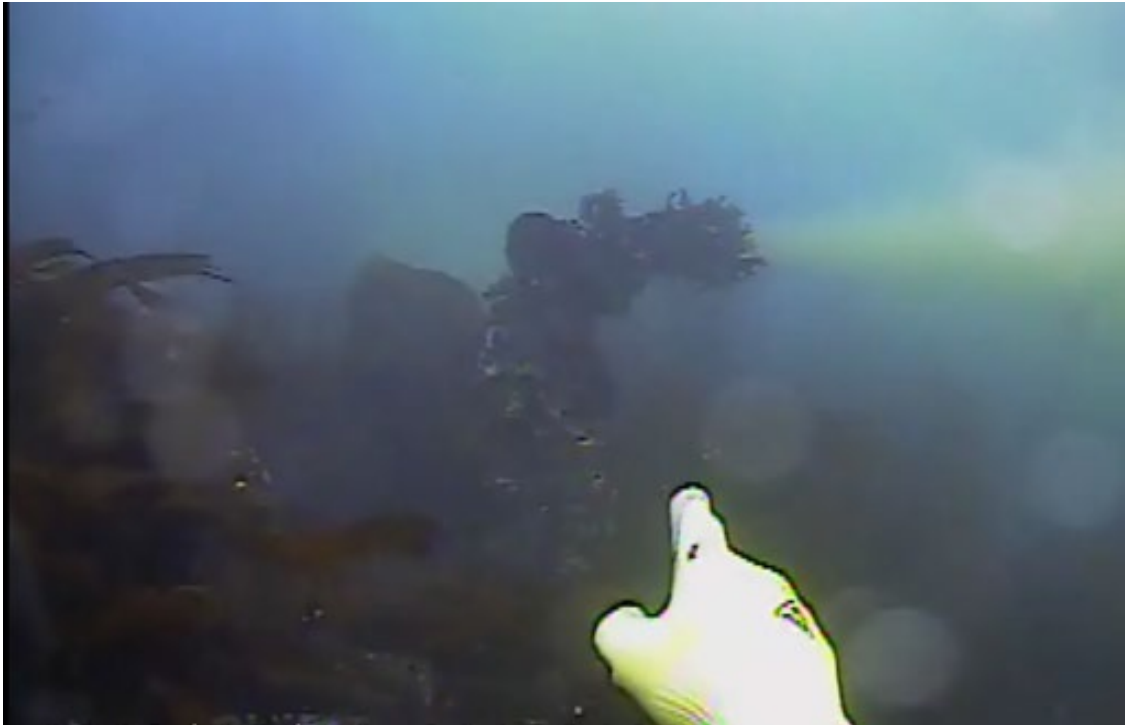
Image 3 – Discharge from Diffuser (typical)

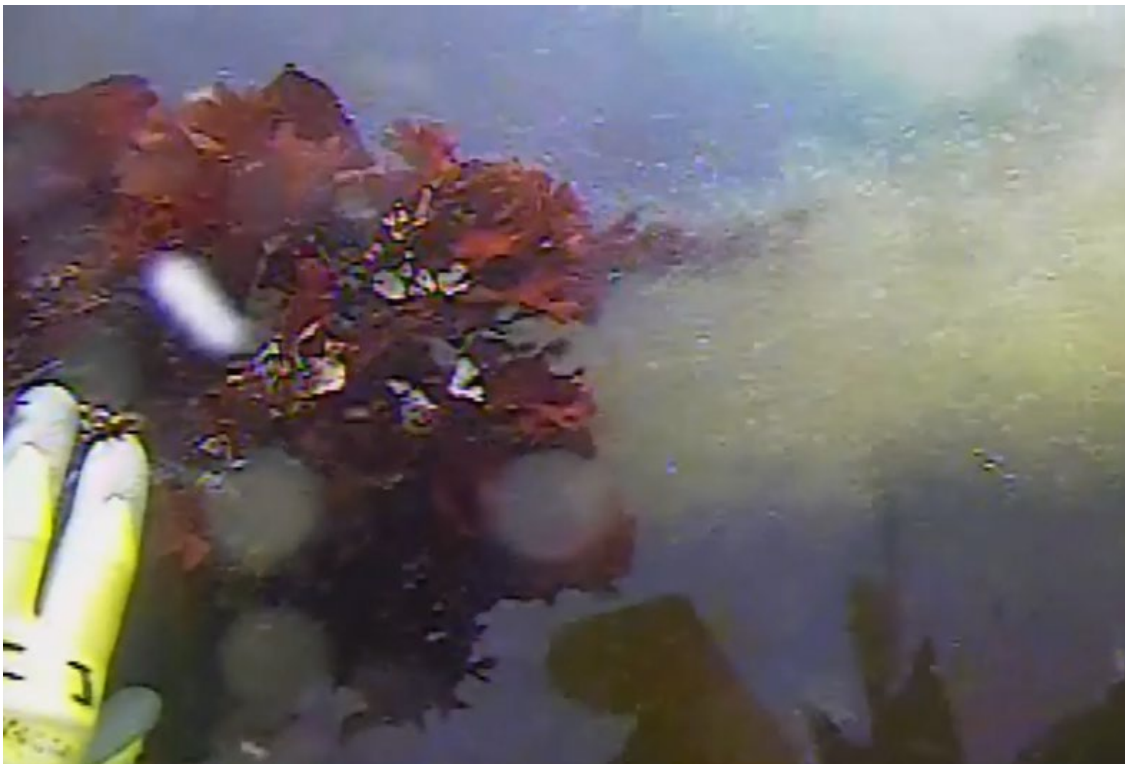
Image 4 – Discharge from Diffuser (typical)

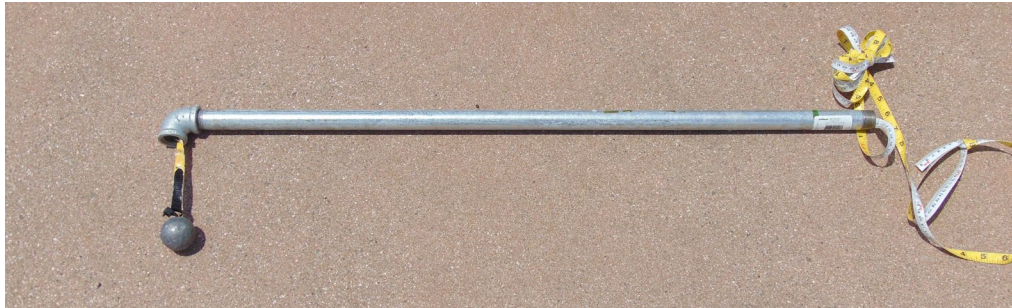
Image 5 – Diffuser sounding device

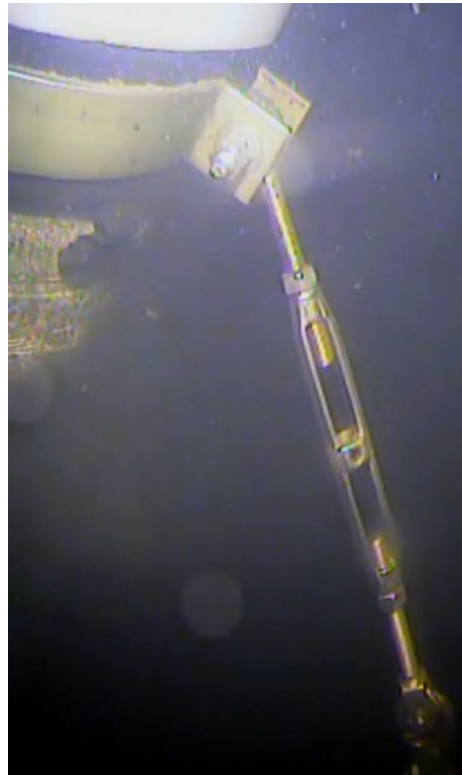
The soft reaction bracing is secure, without observable damage, and appear to be functioning as intended. The two-part clamps are all firmly in place, the cable clips are tight, and the turnbuckles remain snug in tension. The visible portions of the epoxy and woven fiber pile wrap appear to be in good condition and without observable damage, indicating that the upper portion(s) under the UV protective second sheathing wrap can be realistically assumed to be in good condition as well.

Image 6 – Upper clamp-to-turnbuckle connection of soft reaction bracing (typical)

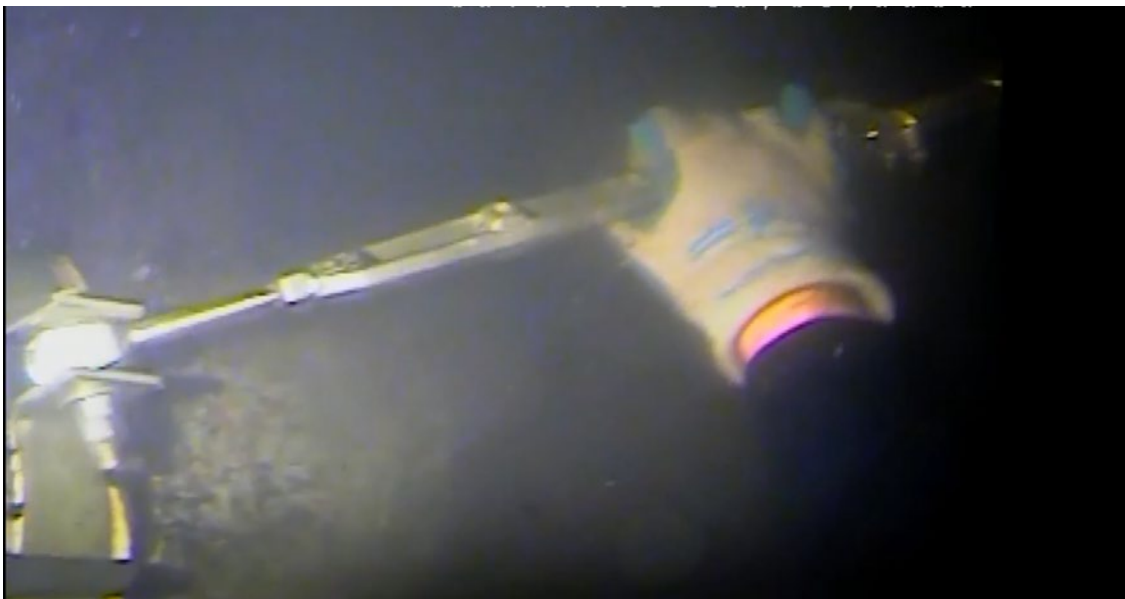
Image 7 – Lower epoxy and woven fiber wrap treatment with two-part clamp (typical)
