**INITIAL STUDY/  
MITIGATED NEGATIVE DECLARATION  
for  
HATTON CANYON  
SEWER REPLACEMENT PROJECT**

**CARMEL AREA WASTEWATER DISTRICT**

**June 2018**

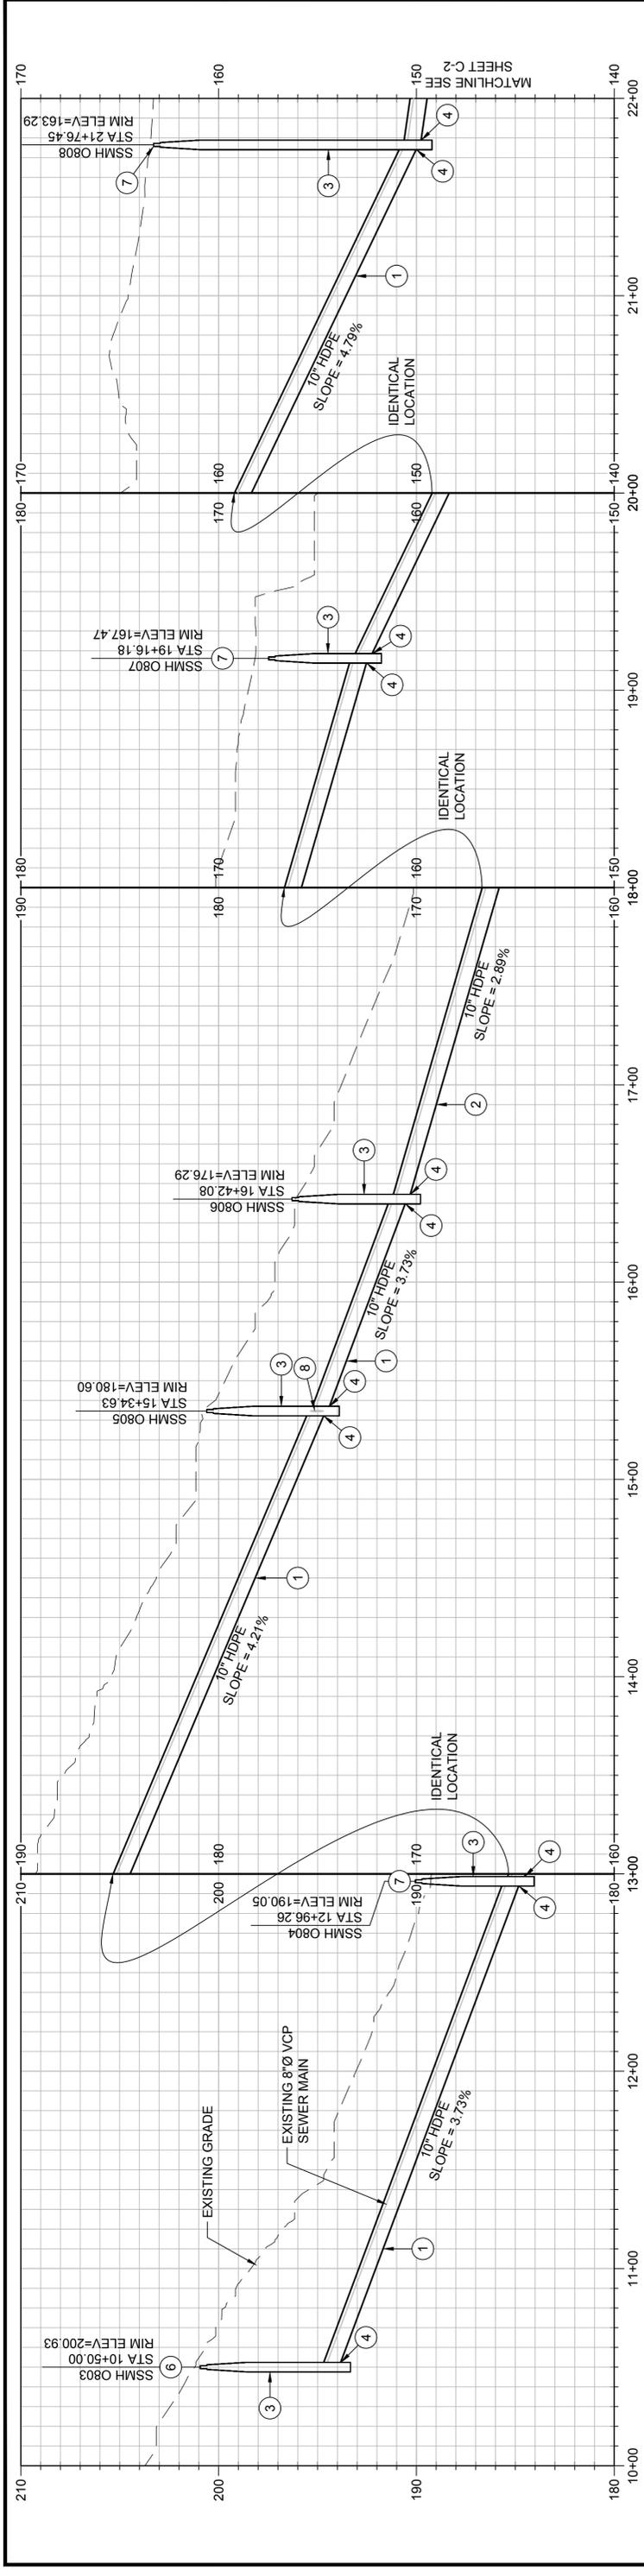
- ① REPLACE EXISTING 8-INCH VCP SEWER MAIN WITH 10-INCH HDPE DR17 BY PIPE BURSTING. SEE SPECIFICATIONS FOR BYPASSING REQUIREMENTS.
- ② REPLACE EXISTING 8-INCH VCP SEWER MAIN WITH 10-INCH HDPE DR17 BY OPEN TRENCH OR PIPE BURSTING. SEE DETAIL 1, SHEET C-6 FOR TRENCH BACKFILL. SEE SPECIFICATIONS FOR BYPASSING REQUIREMENTS.
- ③ WRAP EXTERIOR OF EXISTING MANHOLE TO SEAL JOINTS PER SPECIFICATIONS AND DETAIL 3, SHEET C-6.
- ④ CONNECT 10-INCH HDPE DR17 SEWER MAIN TO EXISTING MANHOLE. SEE DETAIL 4, SHEET C-6.
- ⑤ THE CONTRACTOR'S WORK AREA SHALL BE LIMITED TO THE AREA OF ALLOWABLE DISTURBANCE SHOWN AND EXISTING ACCESS ROADS.
- ⑥ RESET MANHOLE FRAME AND COVER. DEMOLISH AND REPLACE CONCRETE SURROUNDING PER CAWD STANDARD DETAIL SS-9.
- ⑦ RAISE MANHOLE FRAME AND COVER 24 INCHES BY ADDING GRADE RINGS.
- ⑧ PLUG ABANDONED INLET AND RESTORE MANHOLE BENCH.

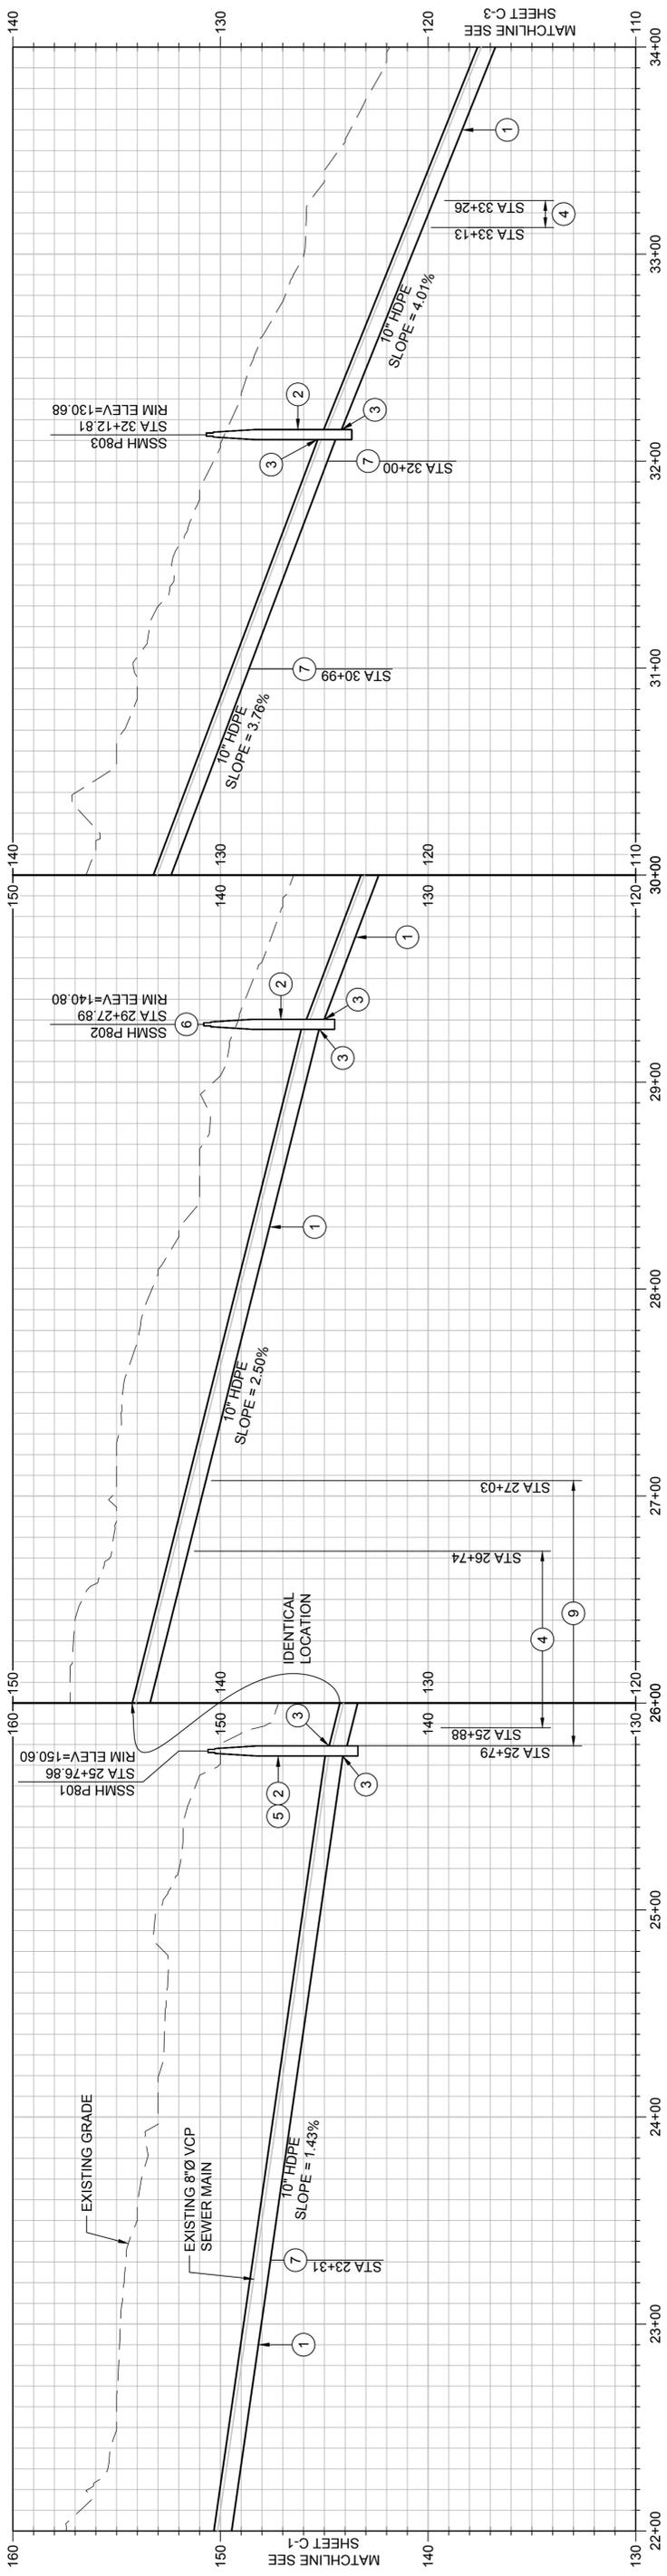
PROJECT NUMBER: CMAWD.170448  
DRAWING NUMBER: C-2  
SHEET NUMBER: 4 OF 8

- 9 REPLACE EXISTING 6-INCH PVC SEWER MAIN WITH 10-INCH HDPE DR17 BY PIPE BURSTING. SEE SPECIFICATIONS FOR BYPASSING REQUIREMENTS.

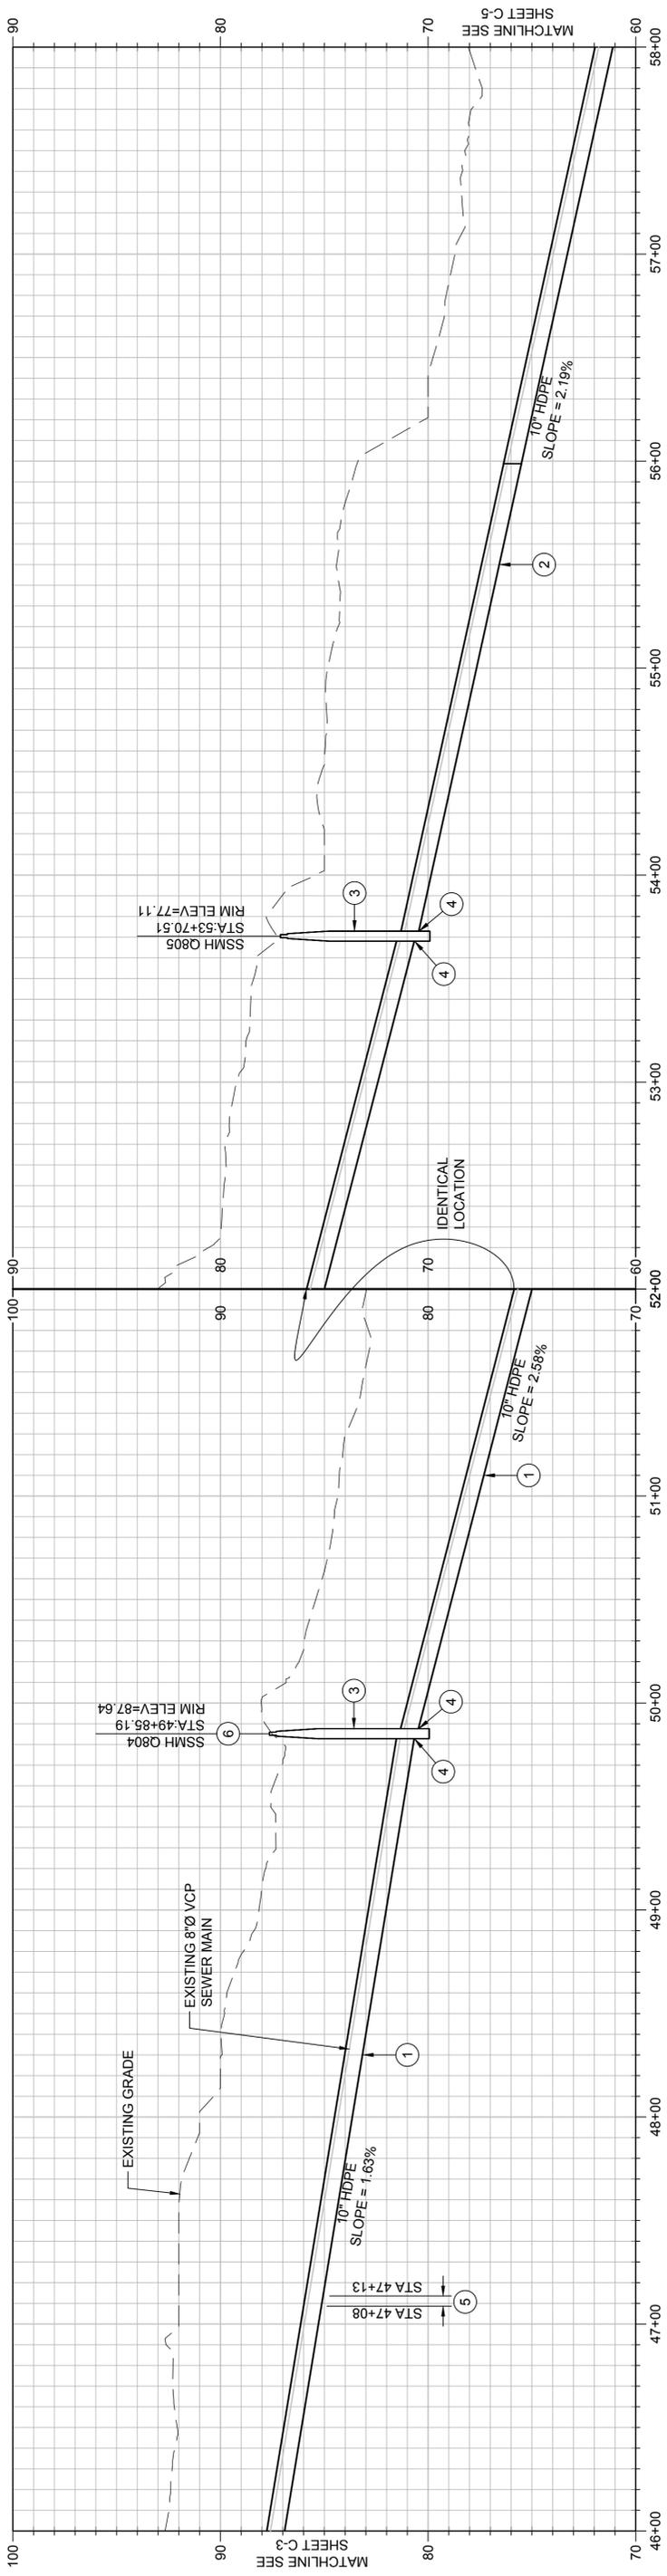
- ① REPLACE EXISTING 8-INCH VCP SEWER MAIN WITH 10-INCH HDPE DR17 BY PIPE BURSTING. SEE SPECIFICATIONS FOR BYPASSING REQUIREMENTS.
- ② REPLACE EXISTING 8-INCH VCP SEWER MAIN WITH 10-INCH HDPE DR17 BY OPEN TRENCH. SEE DETAIL 1, SHEET C-6 FOR TRENCH BACKFILL DETAIL. SEE SPECIFICATIONS FOR BYPASSING REQUIREMENTS.
- ③ WRAP EXTERIOR OF EXISTING MANHOLE TO SEAL JOINTS. SEE DETAIL 3, SHEET C-6 AND THE SPECIFICATIONS.
- ④ CONNECT 10-INCH HDPE DR17 SEWER MAIN TO EXISTING MANHOLE. SEE DETAIL 4, SHEET C-6.
- ⑤ OPEN TRENCH REPAIR SAG AFTER PIPE BURSTING PER SPECIFICATIONS. SEE DETAIL 1, SHEET C-6 FOR TRENCH BACKFILL.
- ⑥ RAISE MANHOLE FRAME AND COVER 24 INCHES BY ADDING GRADE RINGS. SALVAGE EXISTING DISTURBANCE SHOWN AND THE CONTRACTOR'S WORK AREA SHALL BE LIMITED TO THE AREA OF ALLOWABLE DISTURBANCE SHOWN AND EXISTING ACCESS ROADS.
- ⑦ ABANDON EXISTING 8" VCP SEWER MAIN PER SPECIFICATIONS.

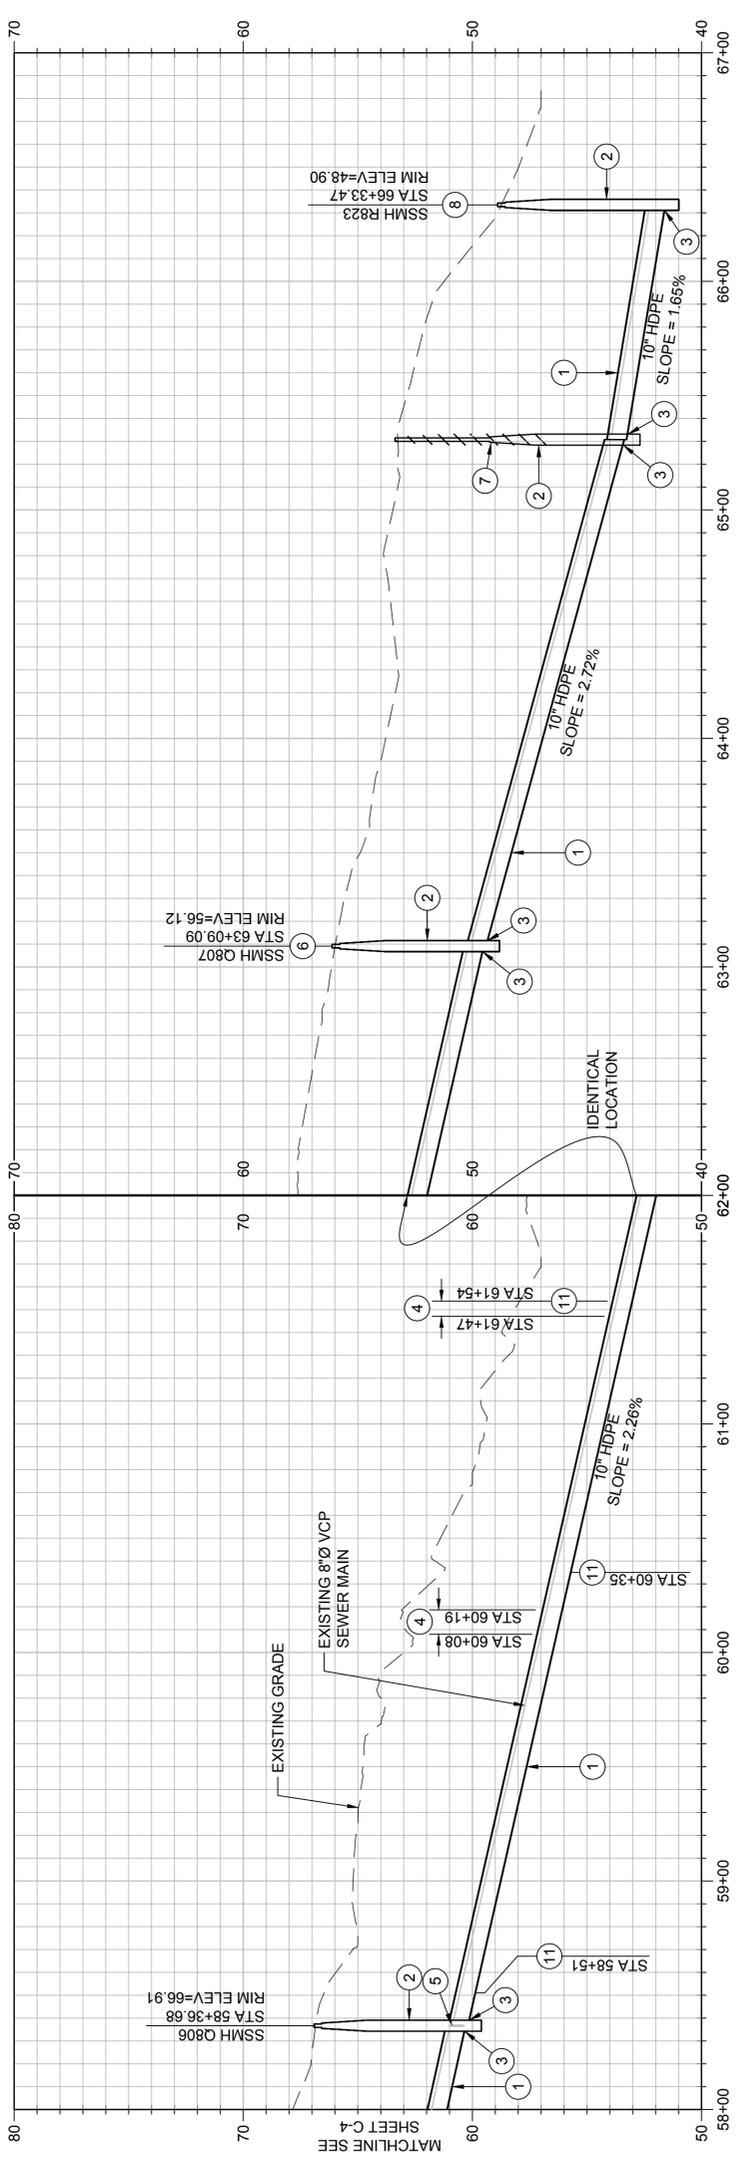
**SEWER PLAN AND PROFILE**  
STA 58+00 TO STA 66+34

- ⑪ RECONNECT SEWER LATERAL PER SPECIFICATIONS AND DETAIL 2, SHEET C-6.
- ⑫ THE CONTRACTOR'S WORK AREA SHALL BE LIMITED TO THE AREA OF ALLOWABLE DISTURBANCE SHOWN AND EXISTING ACCESS ROADS.
