Carmel Area Wastewater District Budget – Volume 2 2020-21

Carmel Area Wastewater District

Table of Contents - Volume 2

Capital Budget Message

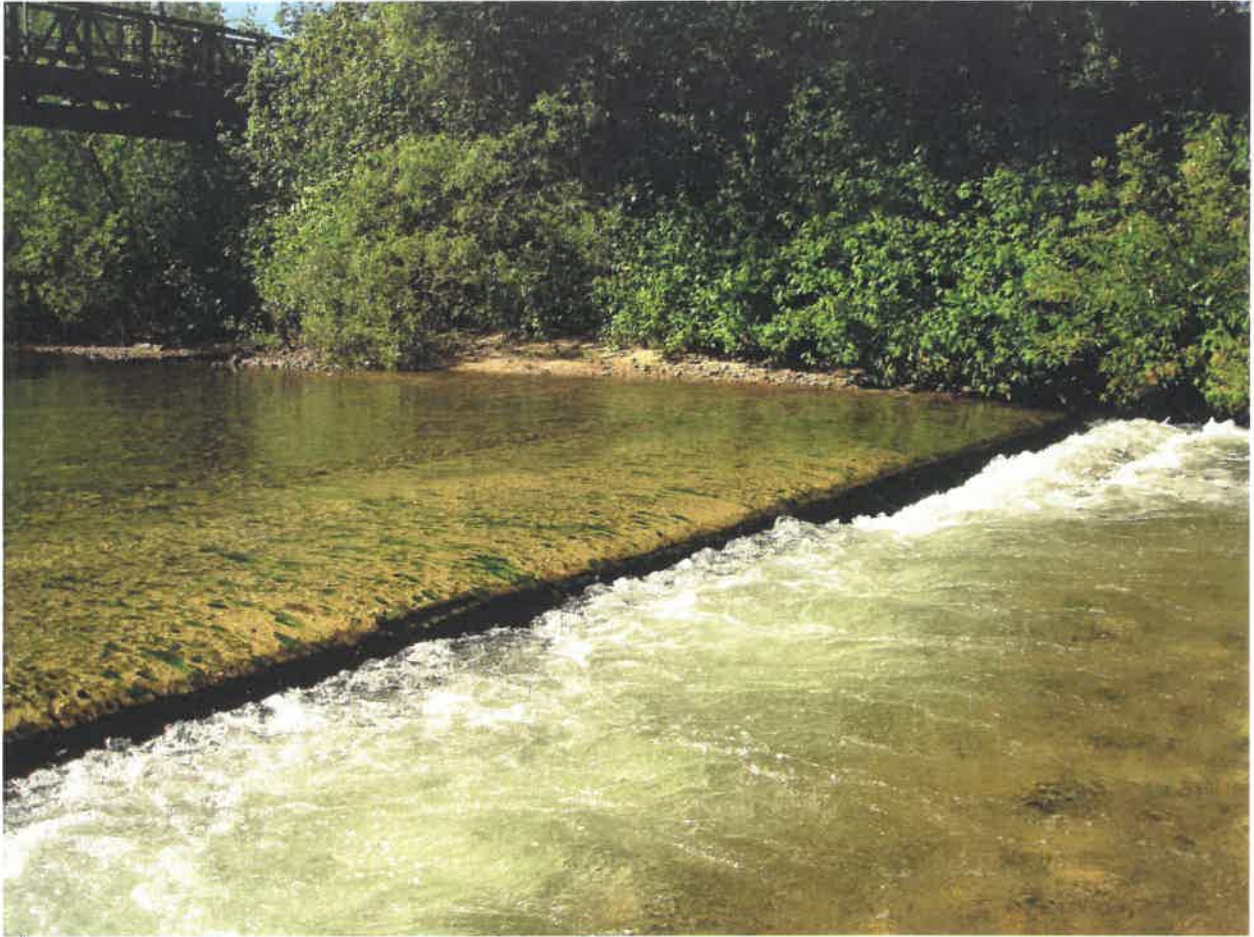
CAWD pipe crossing under Carmel River
