Carmel Area Wastewater District Budget – Volume 2 2020-21

2020-21 Capital Budget

Capital Projects/Maintenance Budget & Long-Range Plan

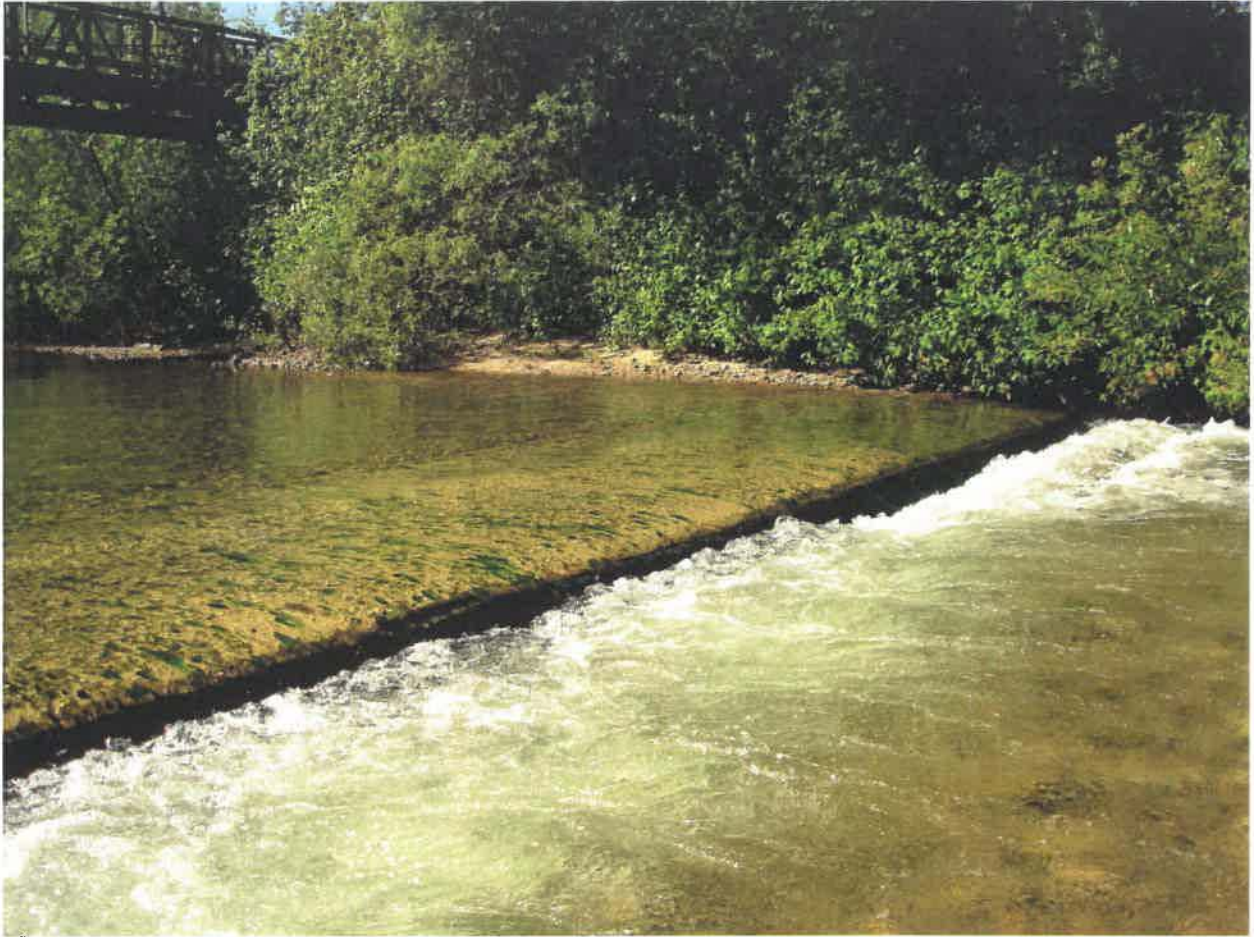
CAWD pipe crossing under Carmel River
